Trail Creek Watershed Analysis

Bureau of Land Management
Medford District, Oregon
June 1999

TRAIL CREEK WATERSHED ANALYSIS

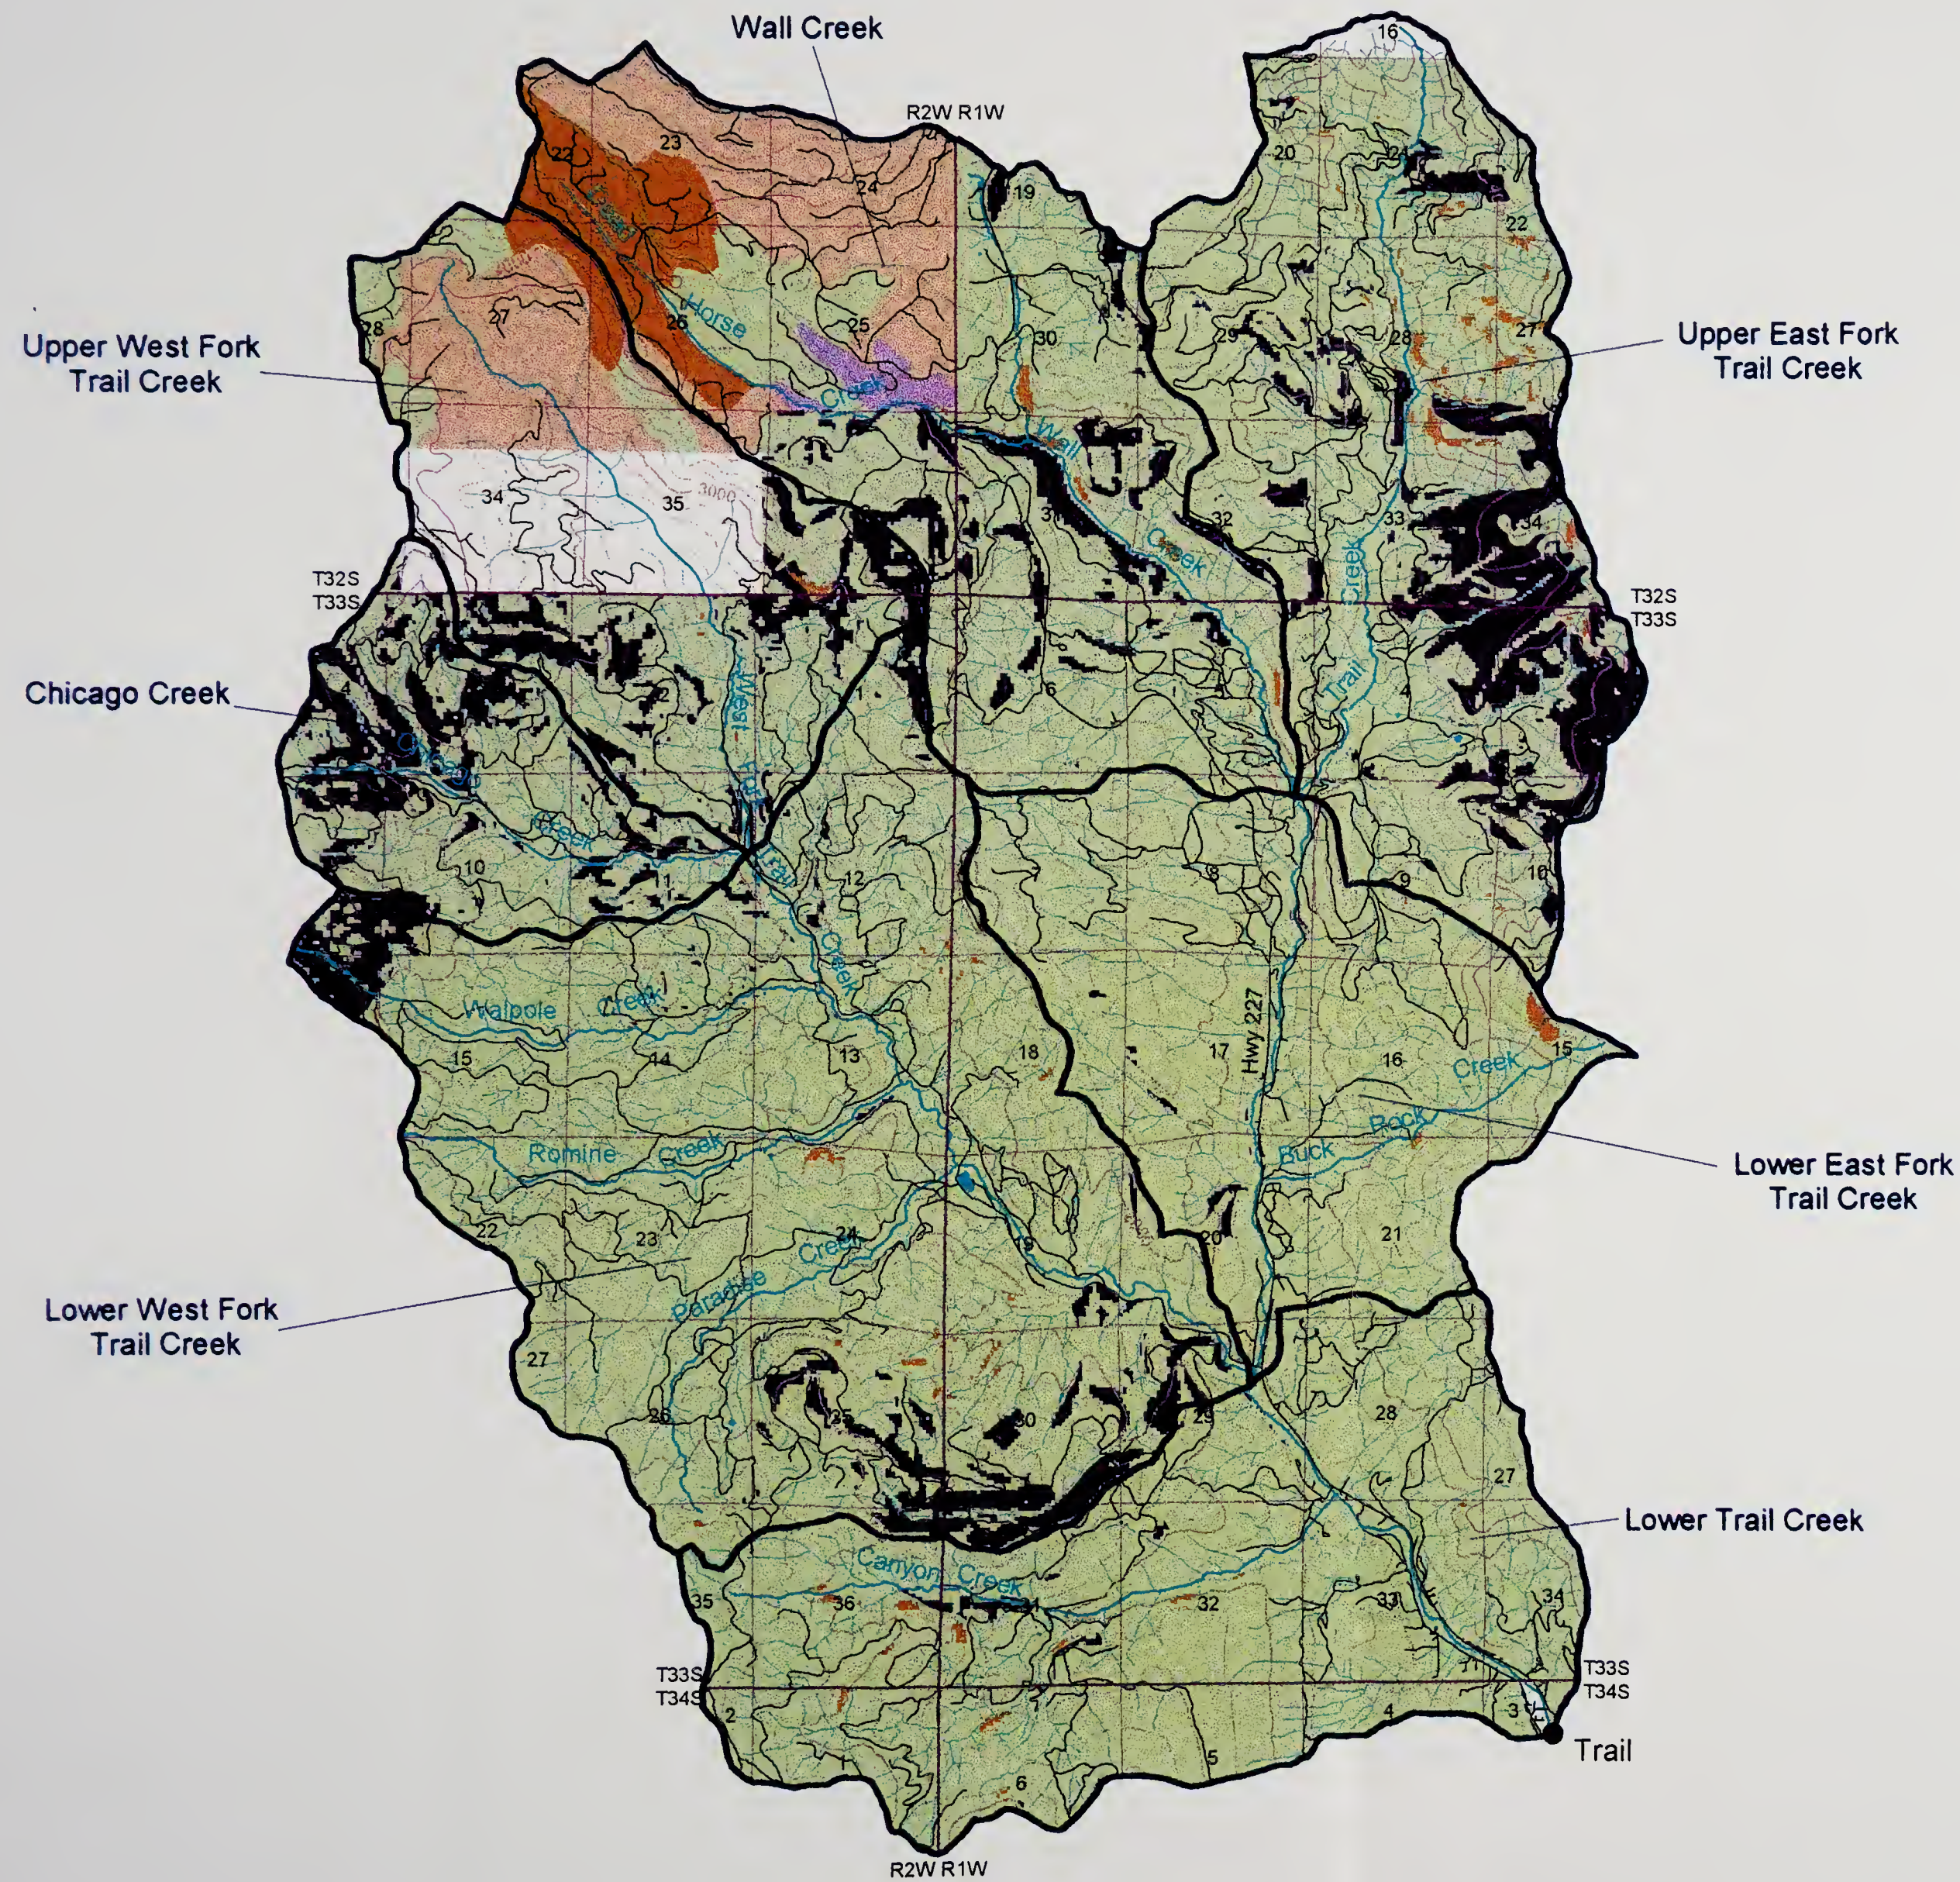
Soil Erosion Potential
Trail Creek Watershed Analysis
Medford District BLM
FIGURE 3-5

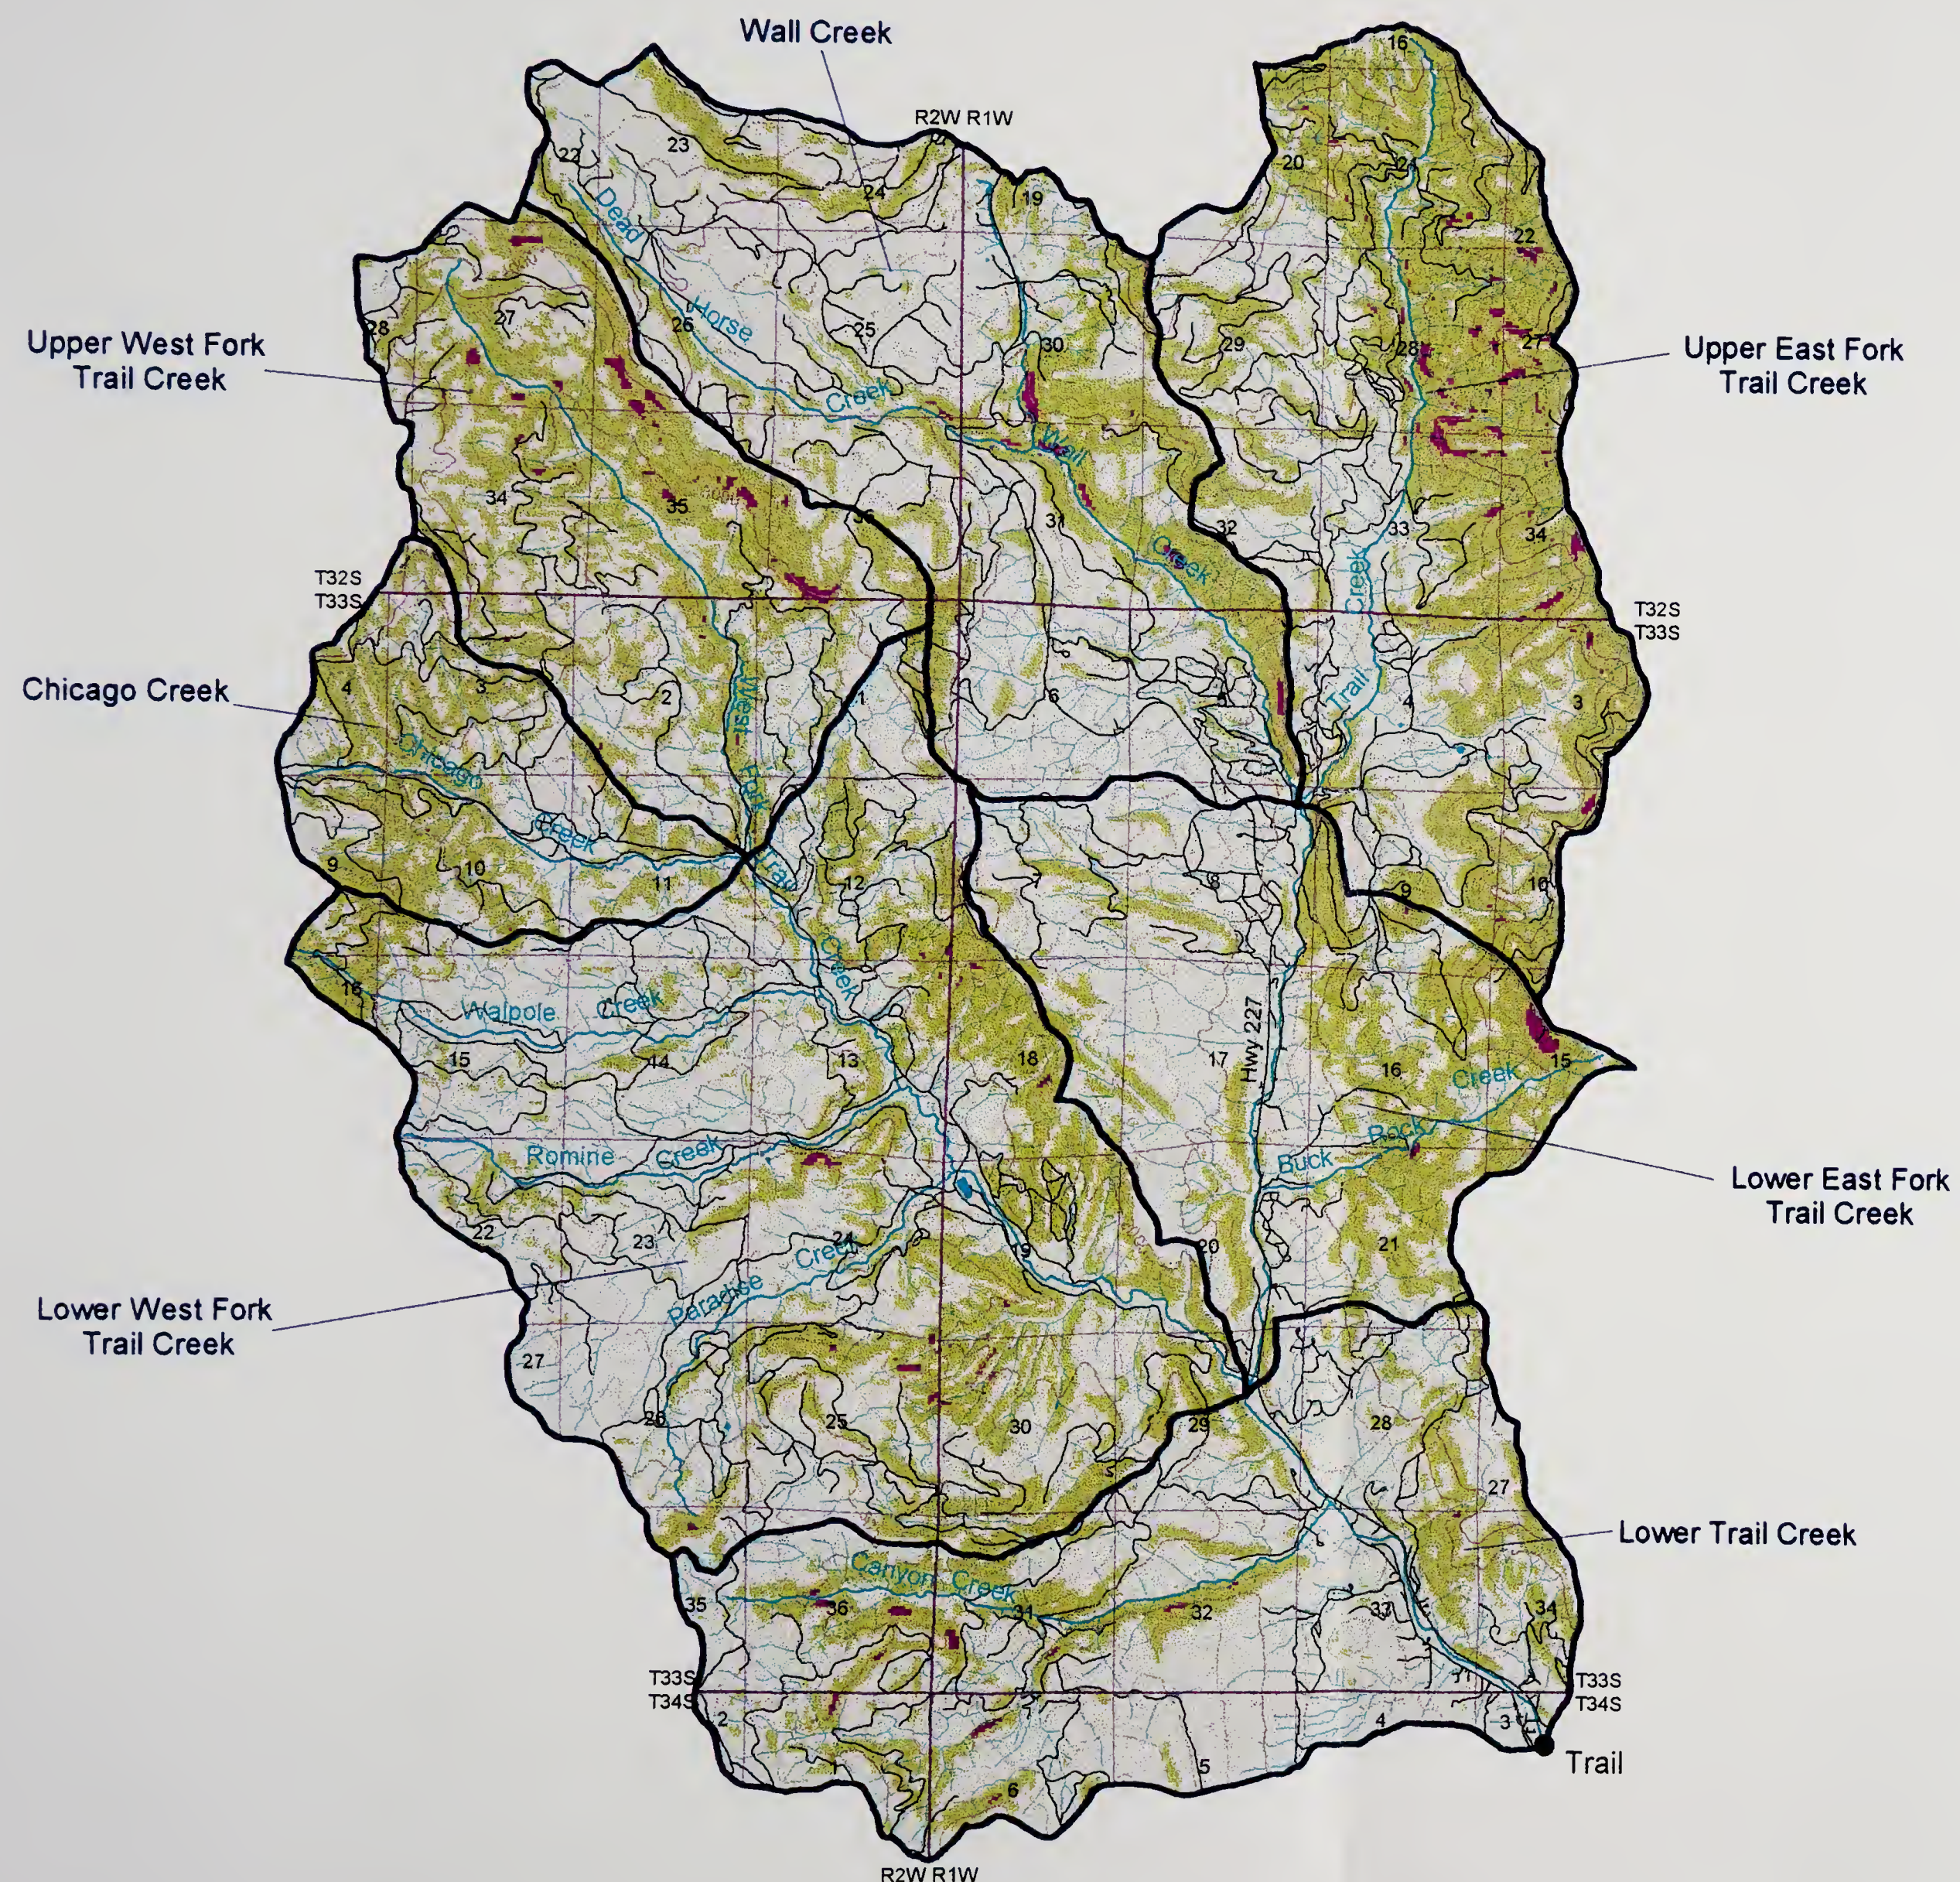
0 - 30% Slope
	30 - 69% Slope
	70% and above

Slope Classes
Trail Creek Watershed Analysis
Medford District BLM
FIGURE 3-6

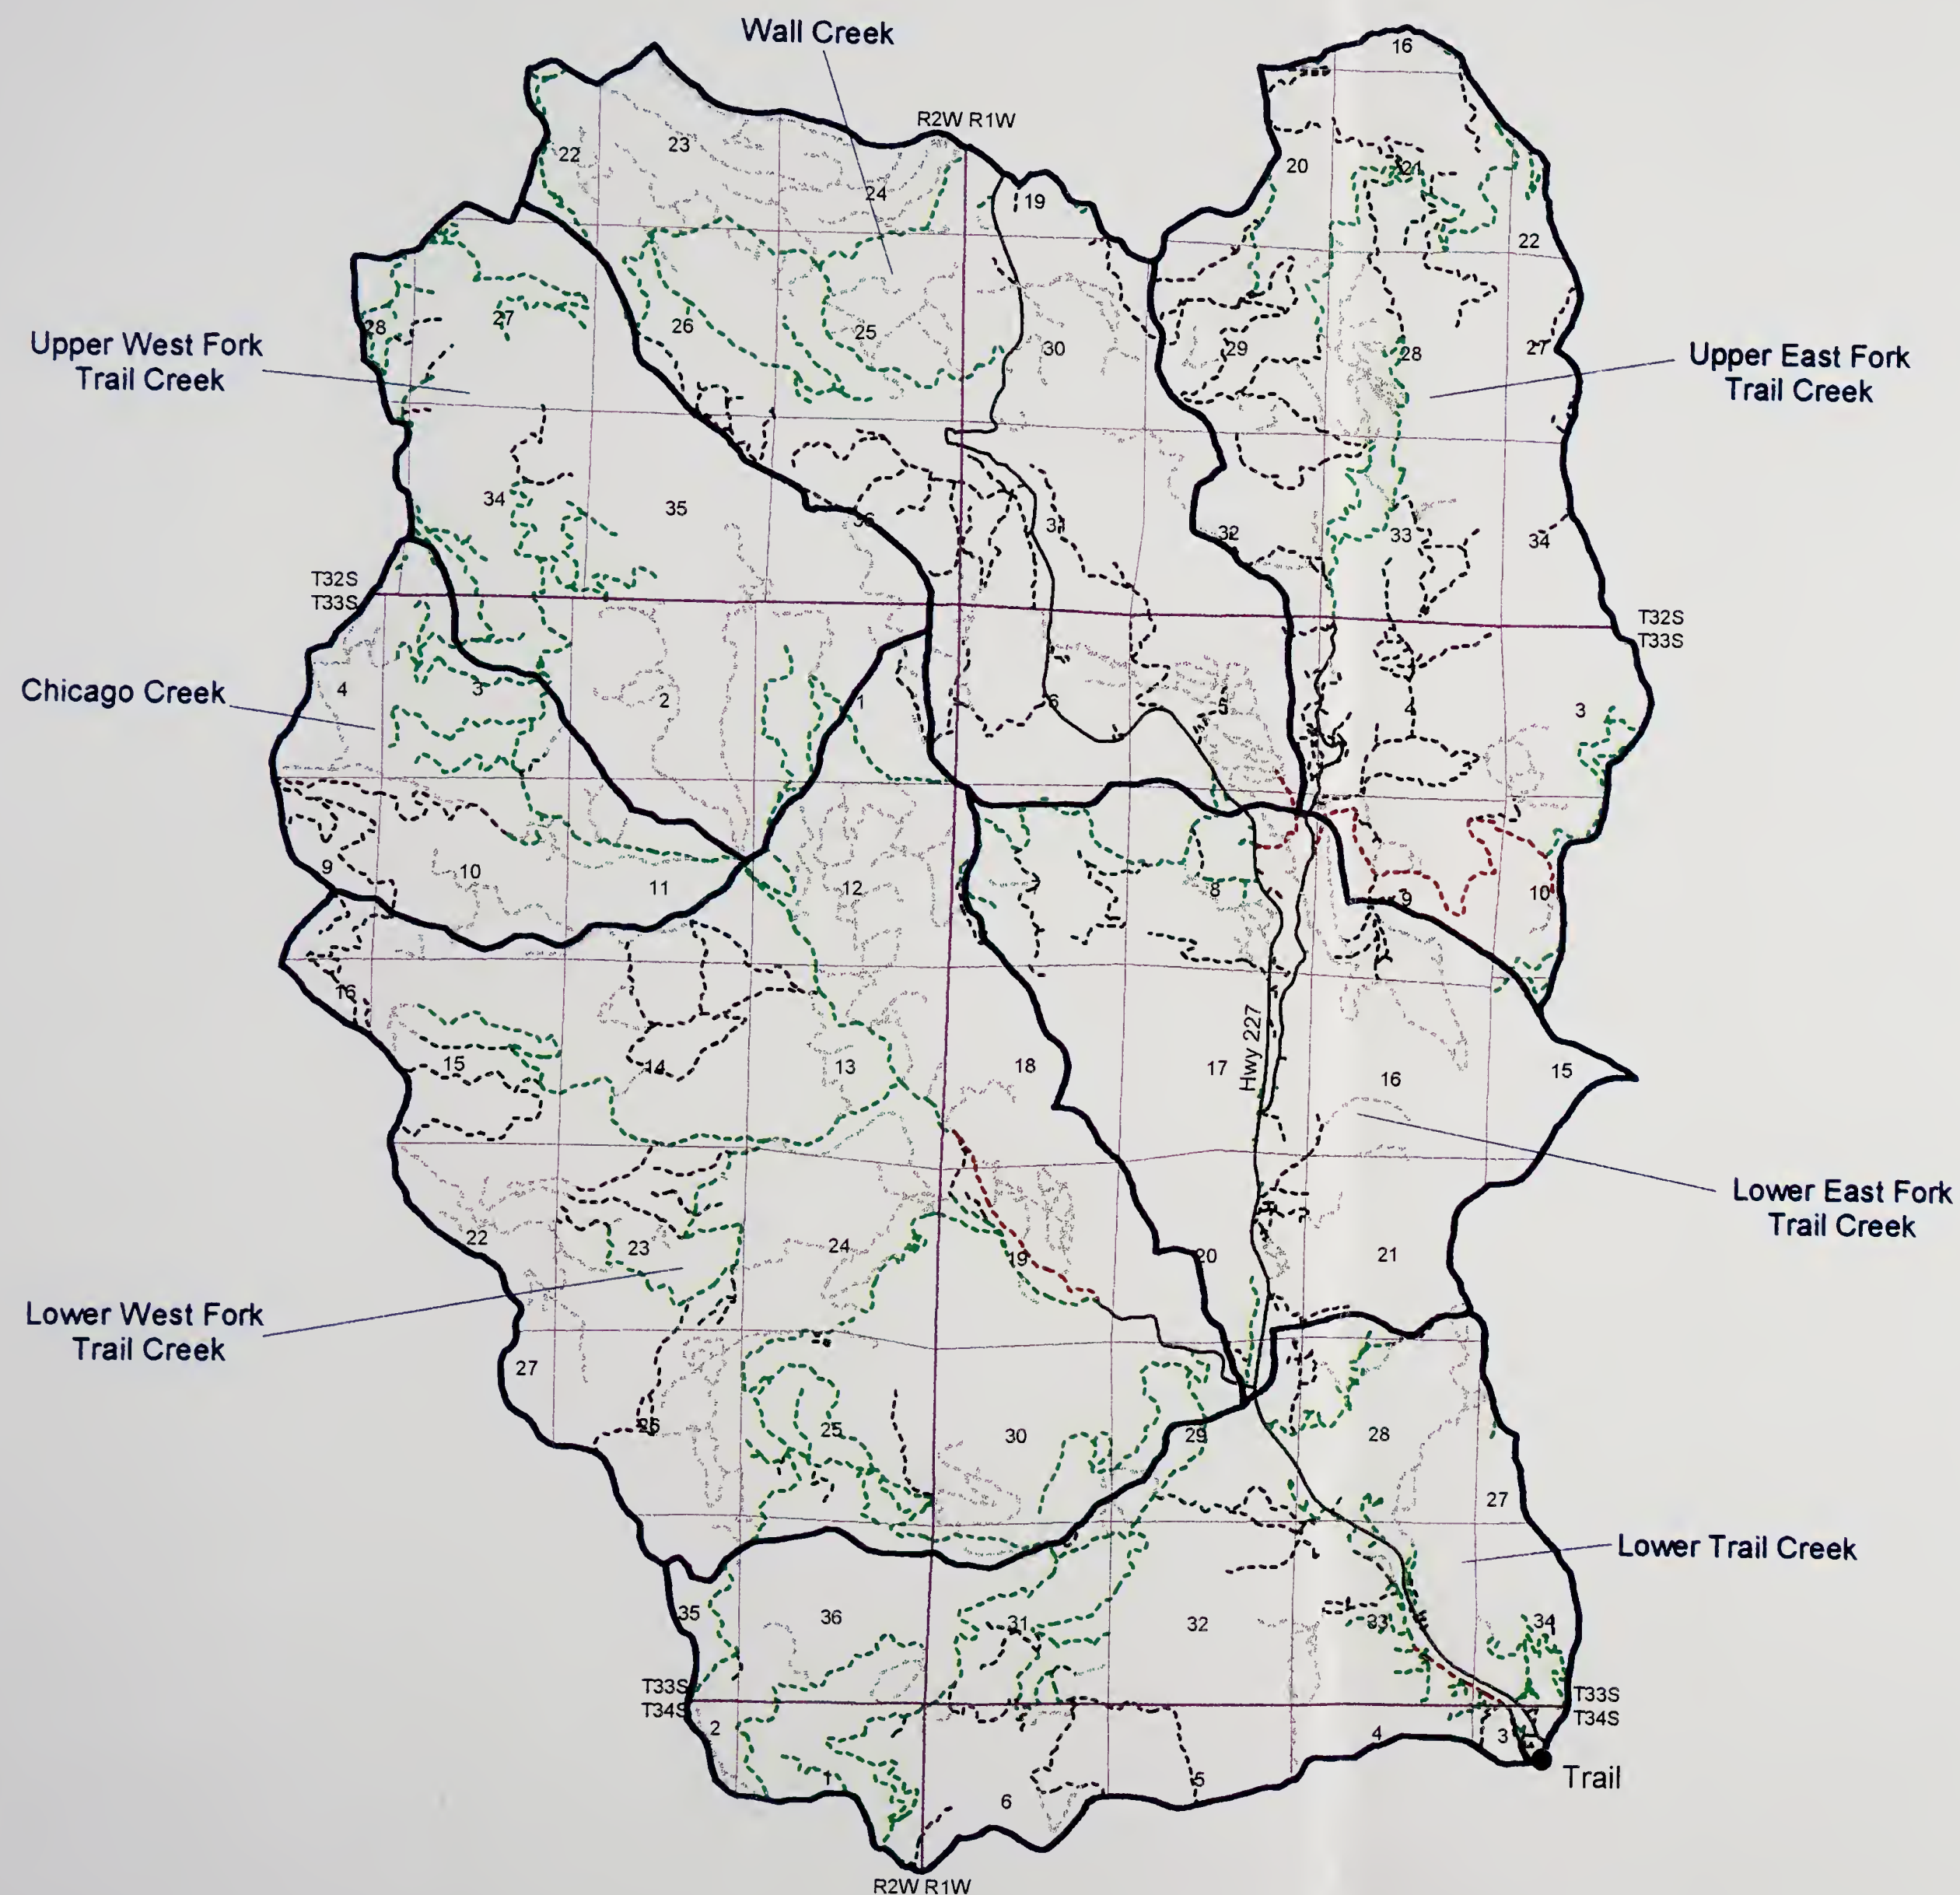
- Road Surfacing and Traffic Classes
- Paved
 - - - Gravelled/ Moderate Use
 - - - Lightly Gravelled / Light Use
 - - - Native Surface / Light Use
 - - - Abandoned / Permanently Closed
 - Sub-Watershed Boundary

Road Types
Trail Creek Watershed Analysis
Medford District BLM
FIGURE 3-7

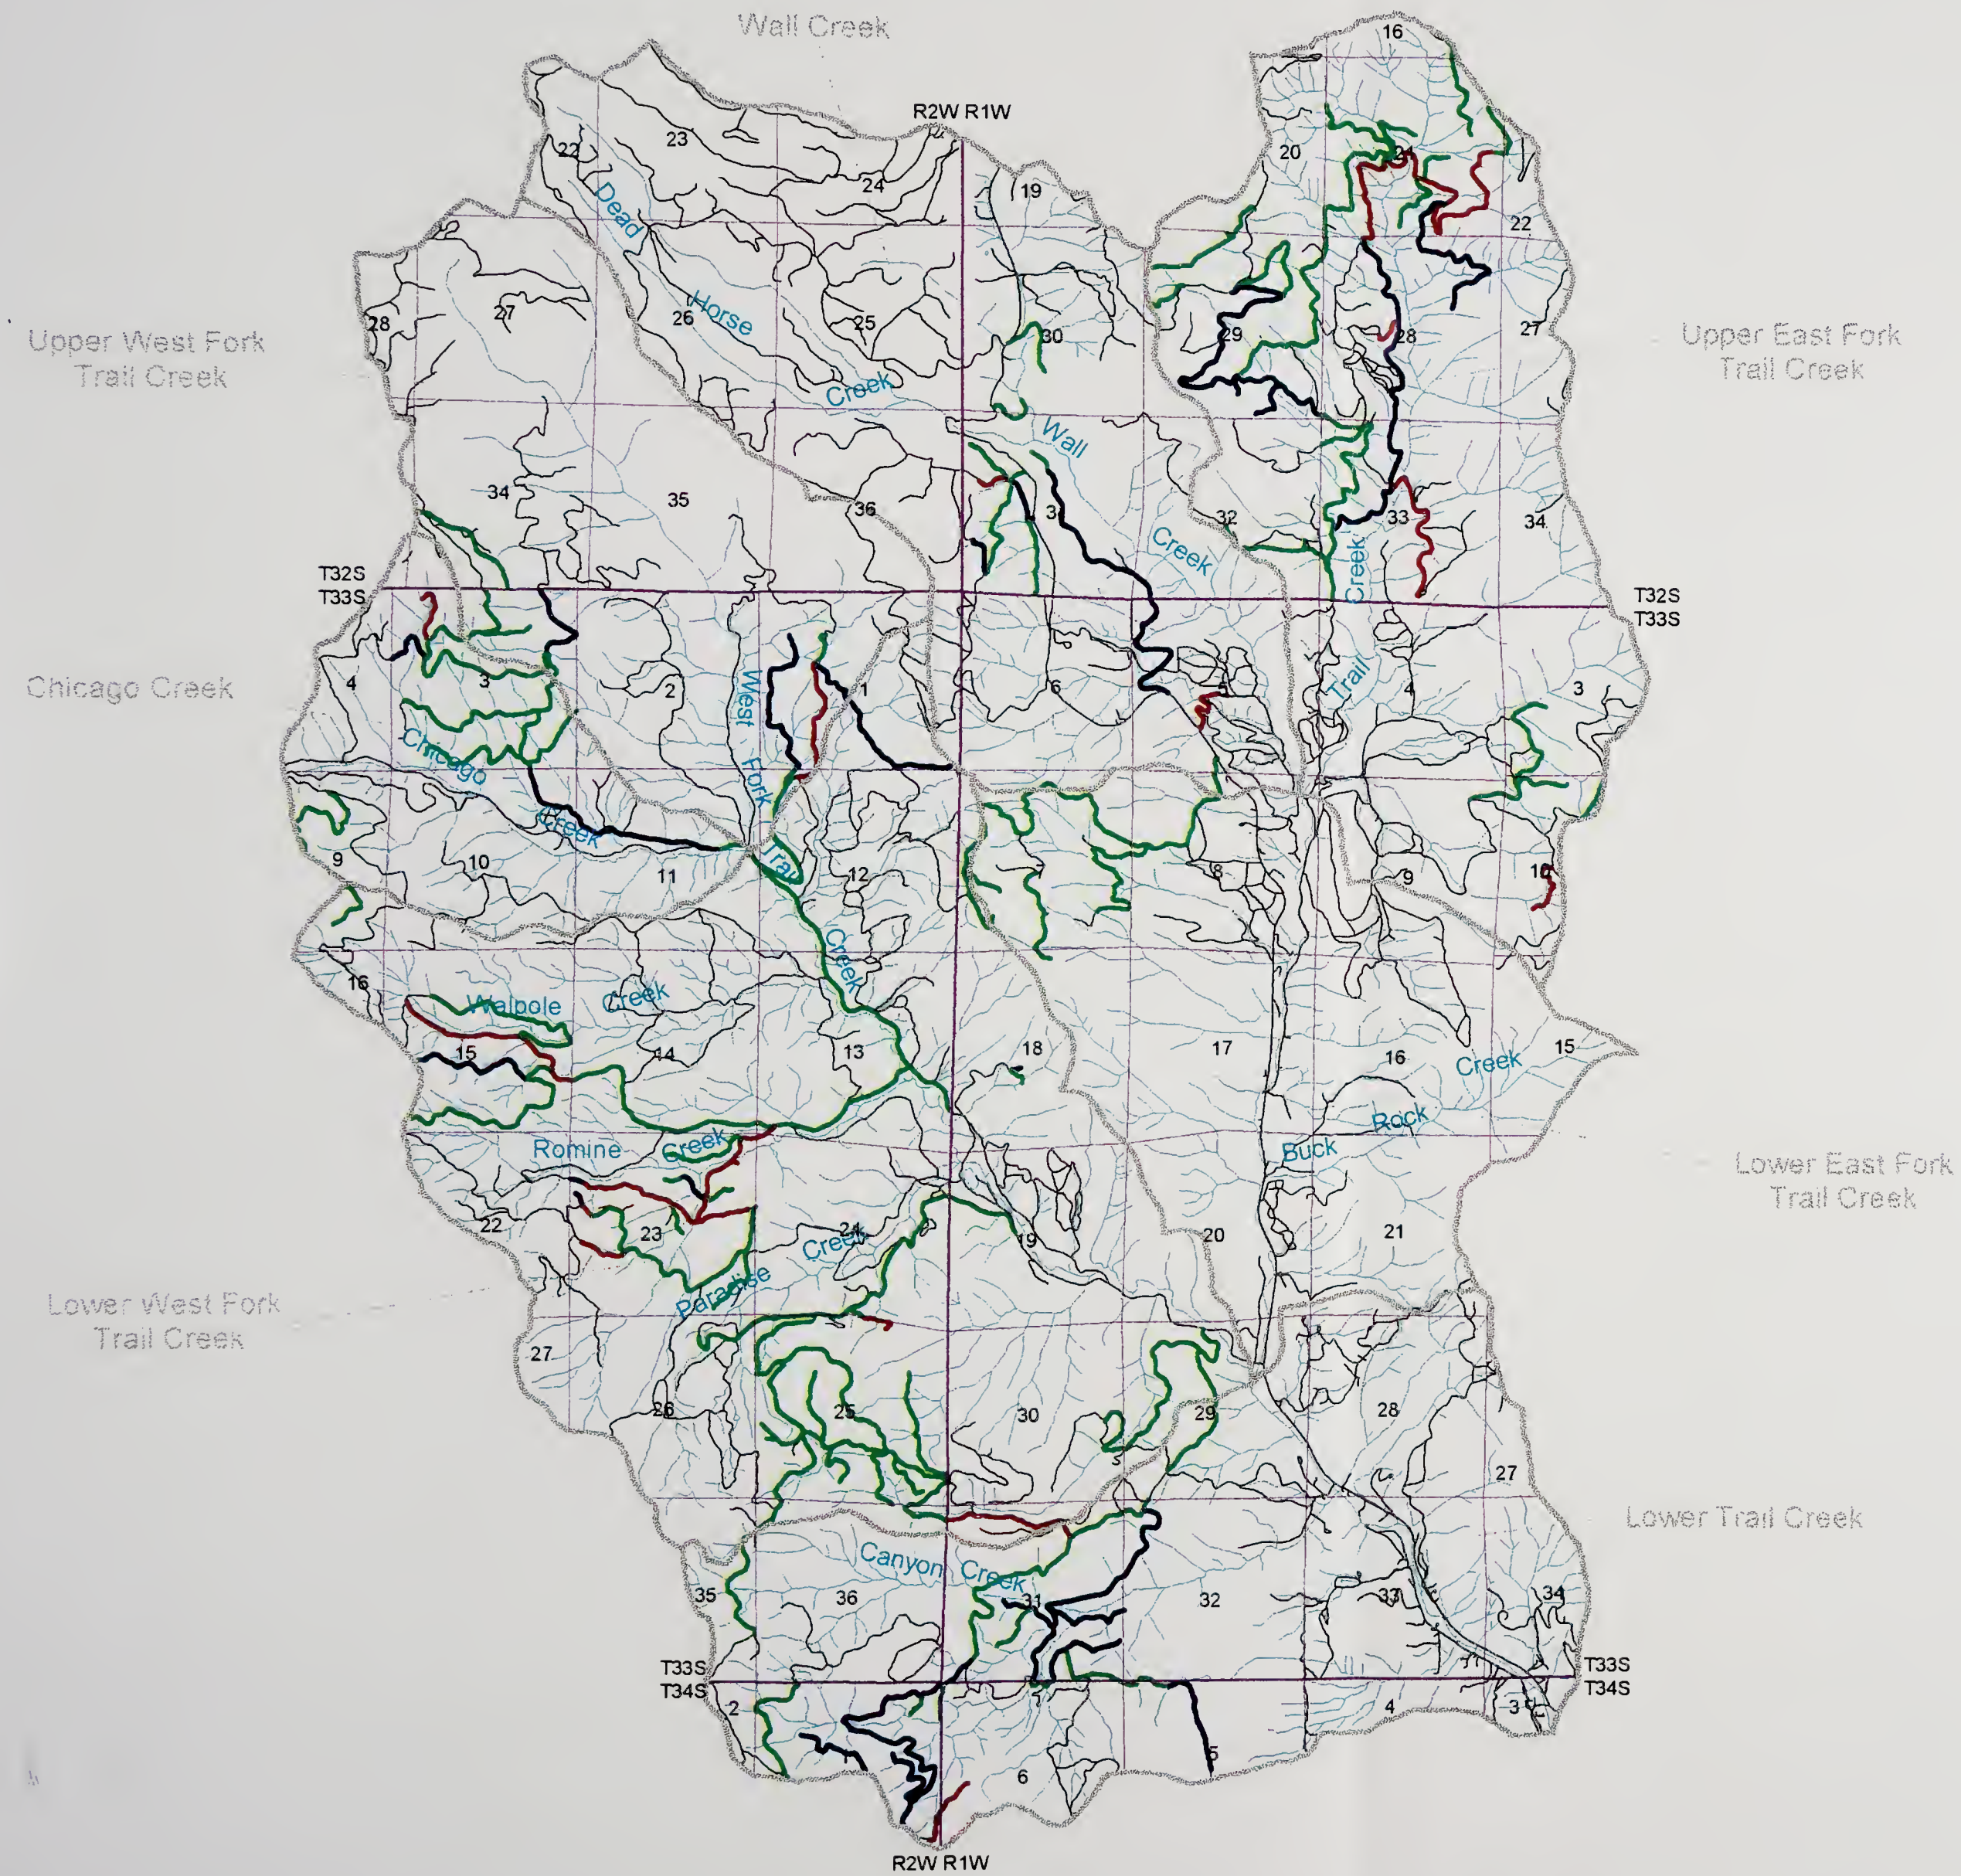
Road Hazards
Trail Creek Watershed Analysis
Medford District BLM
FIGURE 3-8

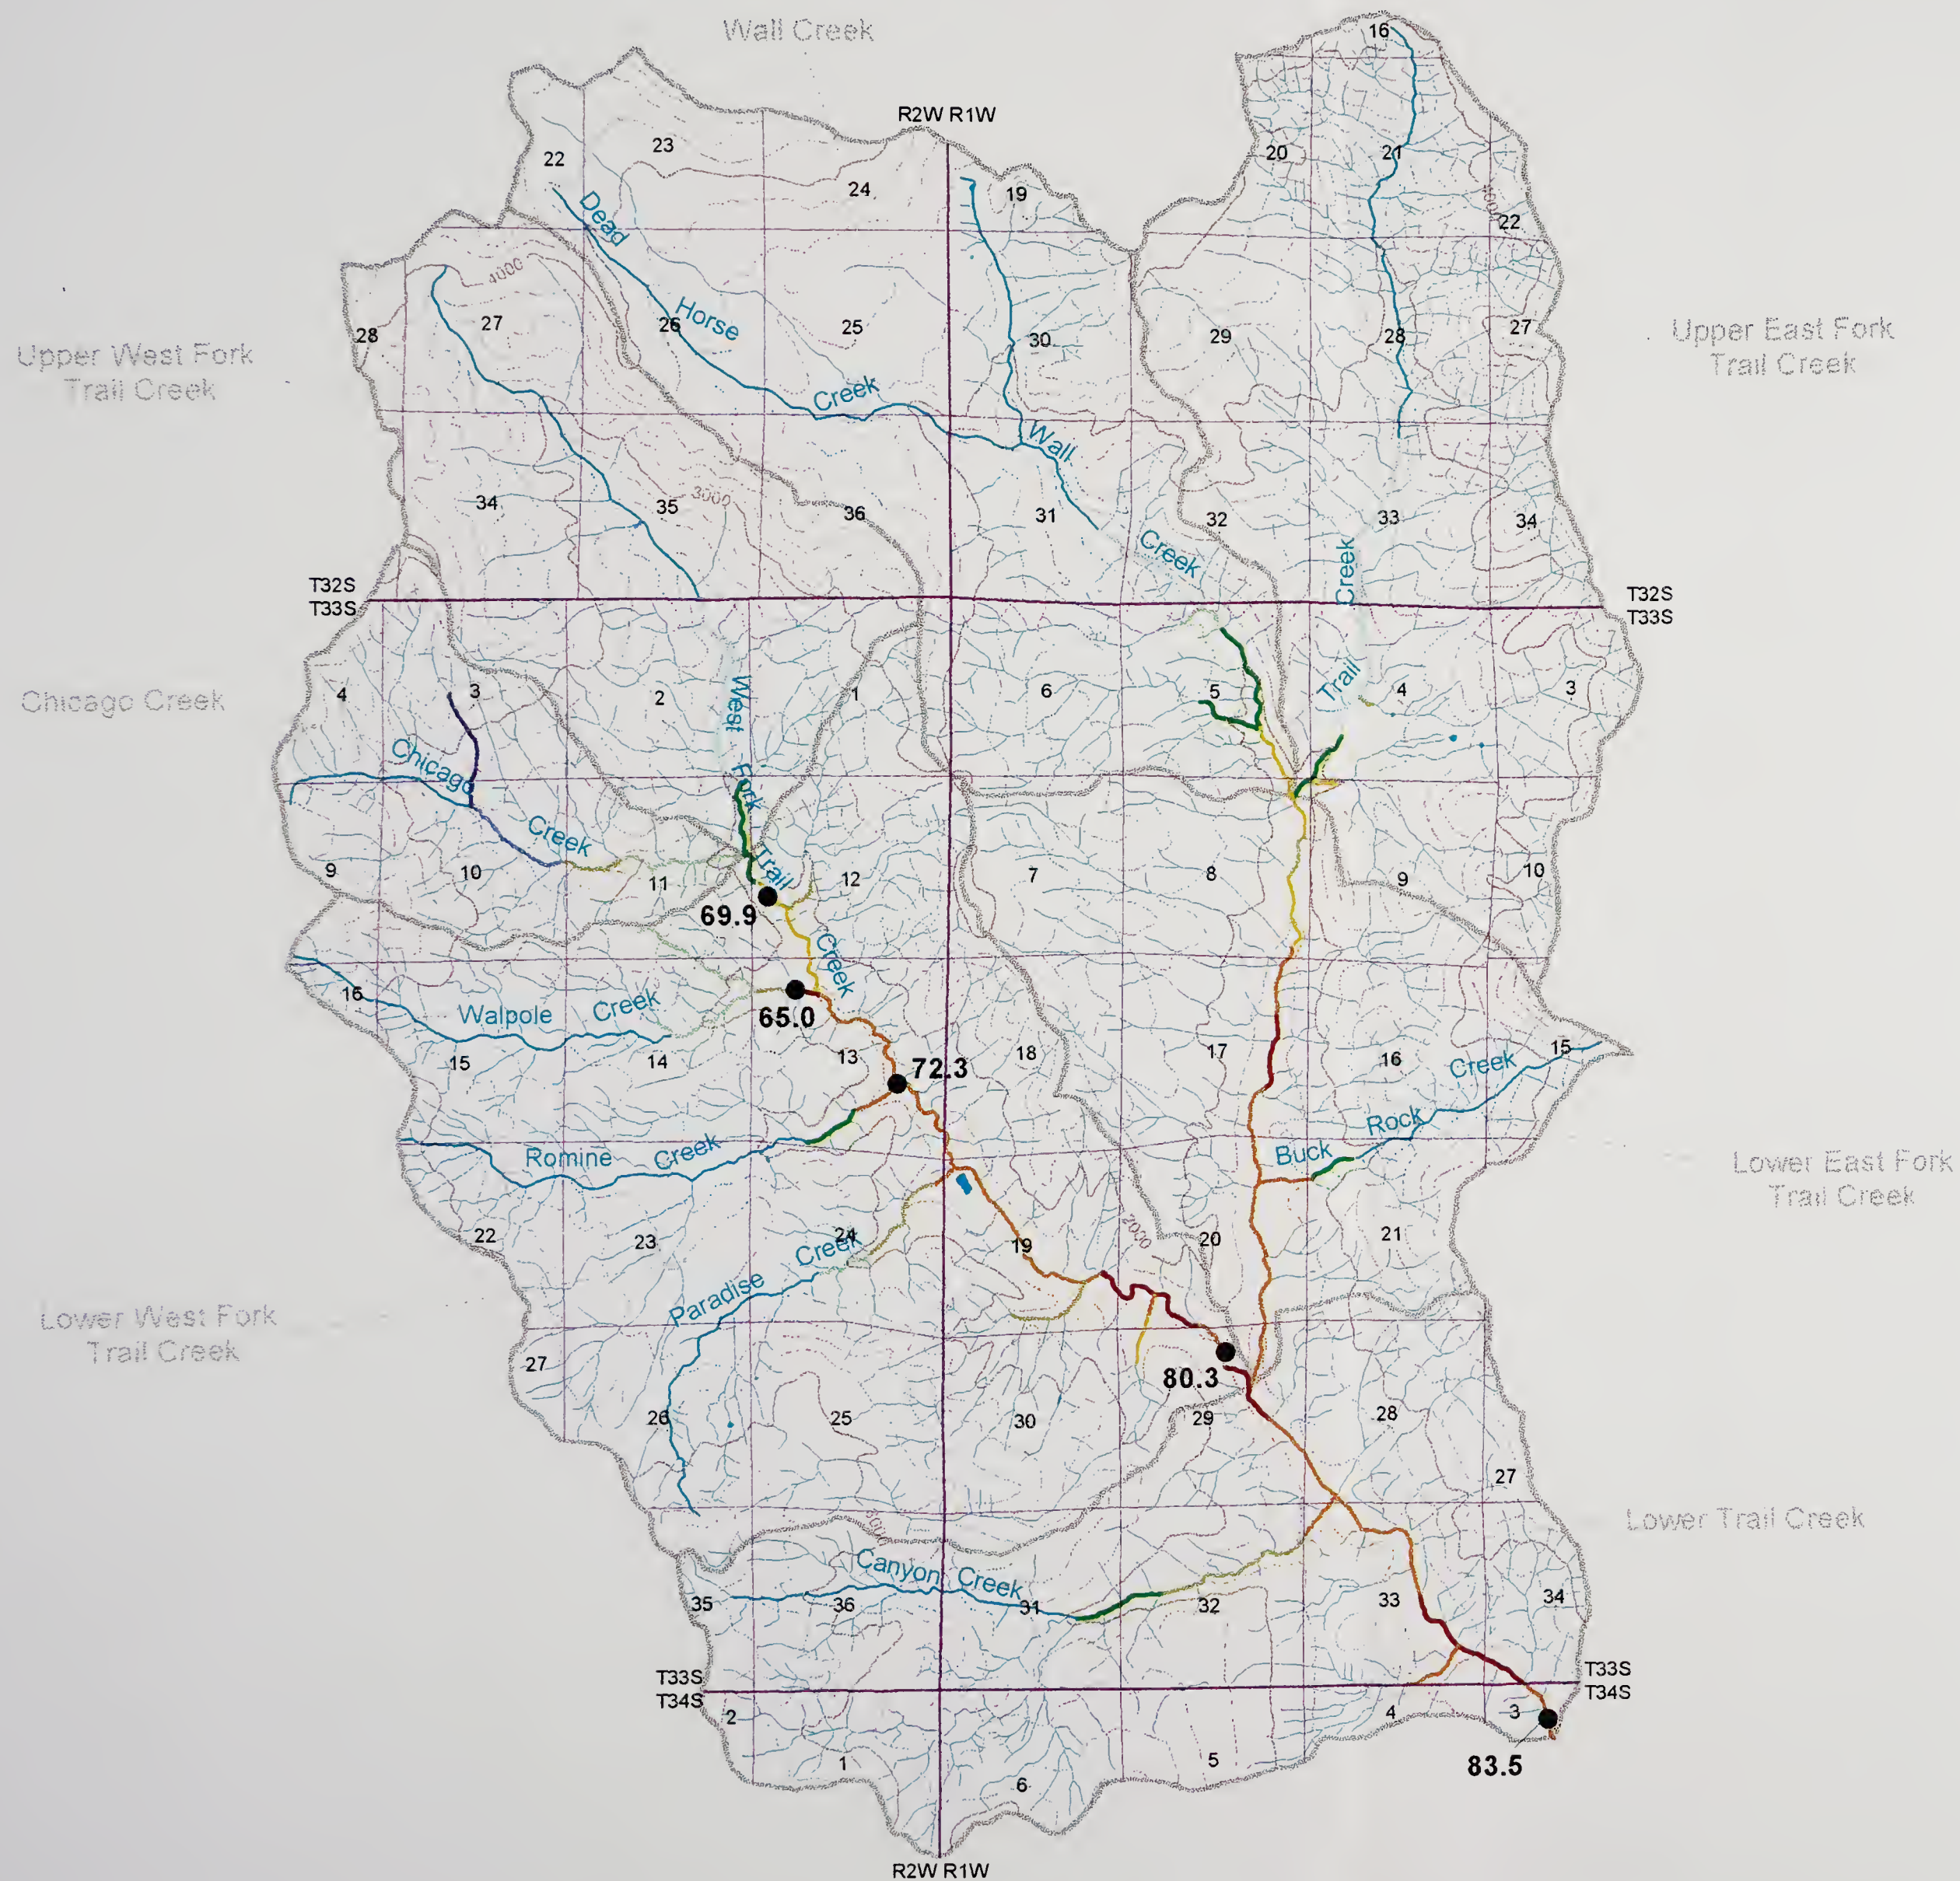
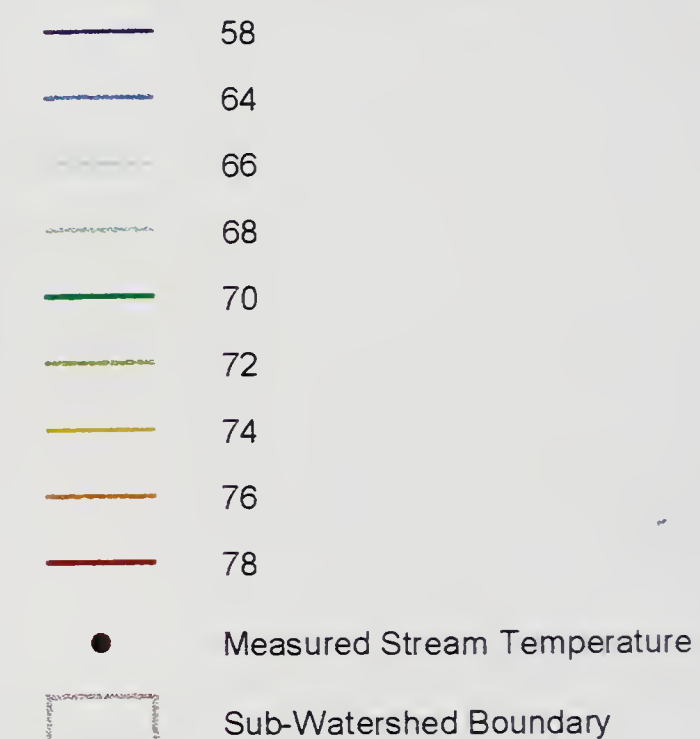
Notes: Measured and Predicted temperatures are expressed in degrees Fahrenheit and equal 7-day average maximum values. Contours equal 200 foot intervals and are labeled at 1000 foot intervals.

**Stream Temperatures
Trail Creek Watershed Analysis
Medford District BLM
FIGURE 3-11**

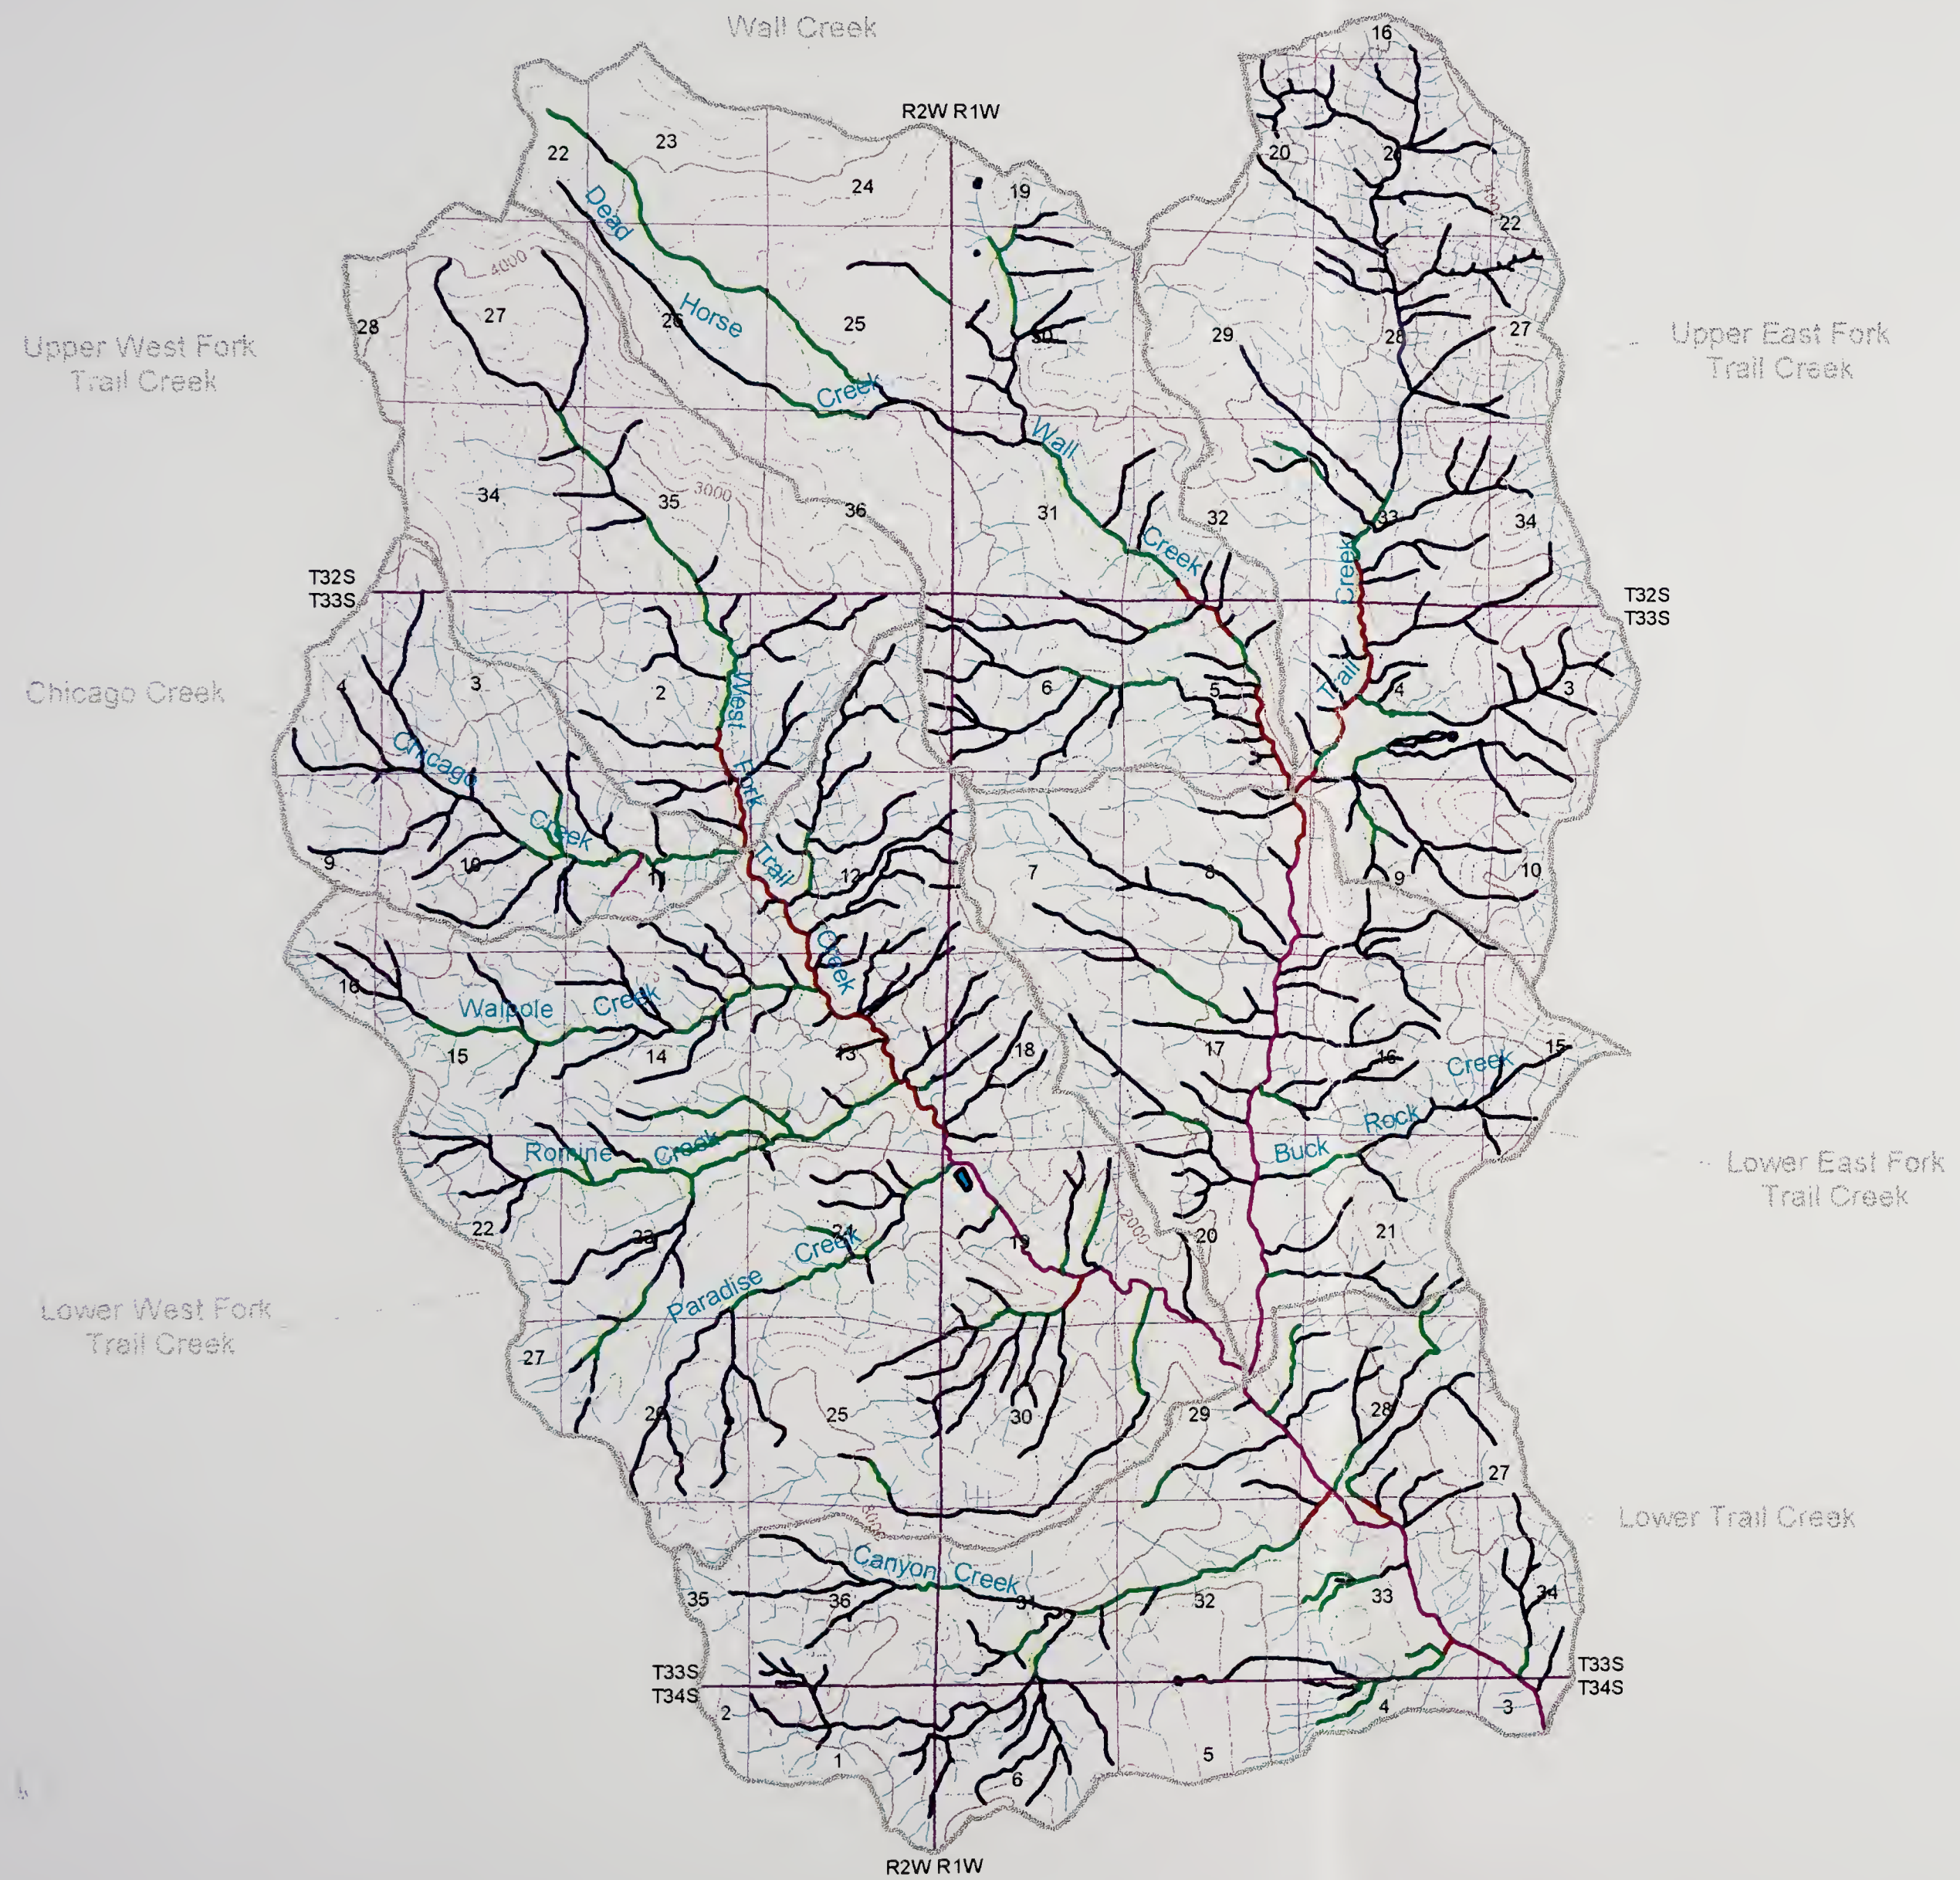
- Rosgen Classifications
- Aa Channels
 - A Channels
 - B Channels
 - C Channels
 - Sub-Watershed Boundary

**Rosgen Classifications
Trail Creek Watershed Analysis
Medford District BLM
FIGURE 3-12**
